# Hydrothermal Alteration of Cementitious Materials Part II: Second and Third Batch of Samples

K.B.L. Myers  
A. Meike

October 25, 1997

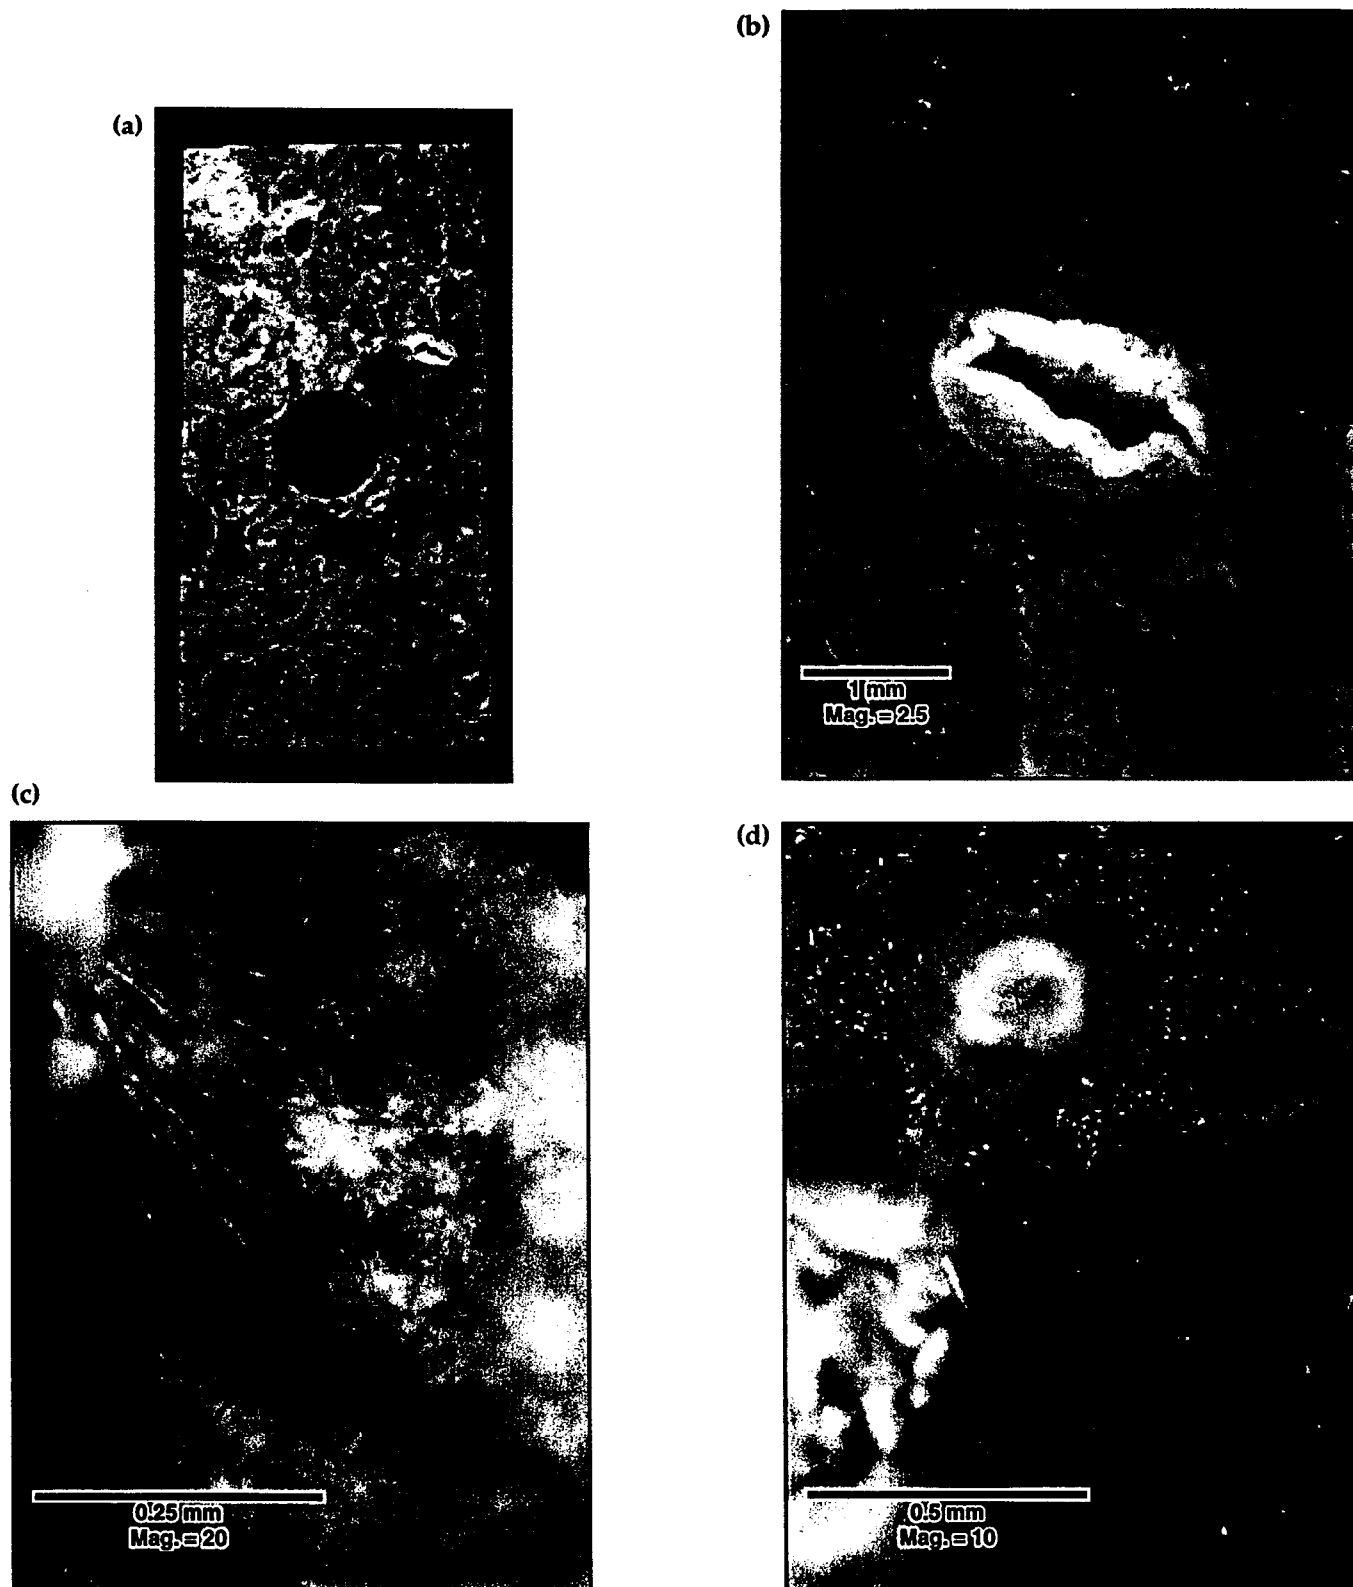
Figure 23. Photographs of sample INV-33. (a) White rims occur around some aggregate grains. A white crust sparsely coats some of the sample. (b) A raised white rim within an aggregate grain. Only one raised rim occurs on each side of the sample. (c) Two morphologies of the white crust that sparsely coat the sample. The examples in the photo are shown on aggregate. (d) A patch of noncoated area containing a small grain with a white rim.

**Invert. Vapor treatment. Sample INV-33.** The photos (Figure 23) show that white rims occur around some aggregate grains, and a white crust sparsely coats some of the sample. An unusual raised white rim was observed within an aggregate grain. Only one raised rim occurs on each side of the sample. Also shown are two morphologies of the white crust-forming phases that sparsely coat the sample. The examples in the photo are shown on aggregate. Although sparse, some small grains within the noncoated areas have white rims.

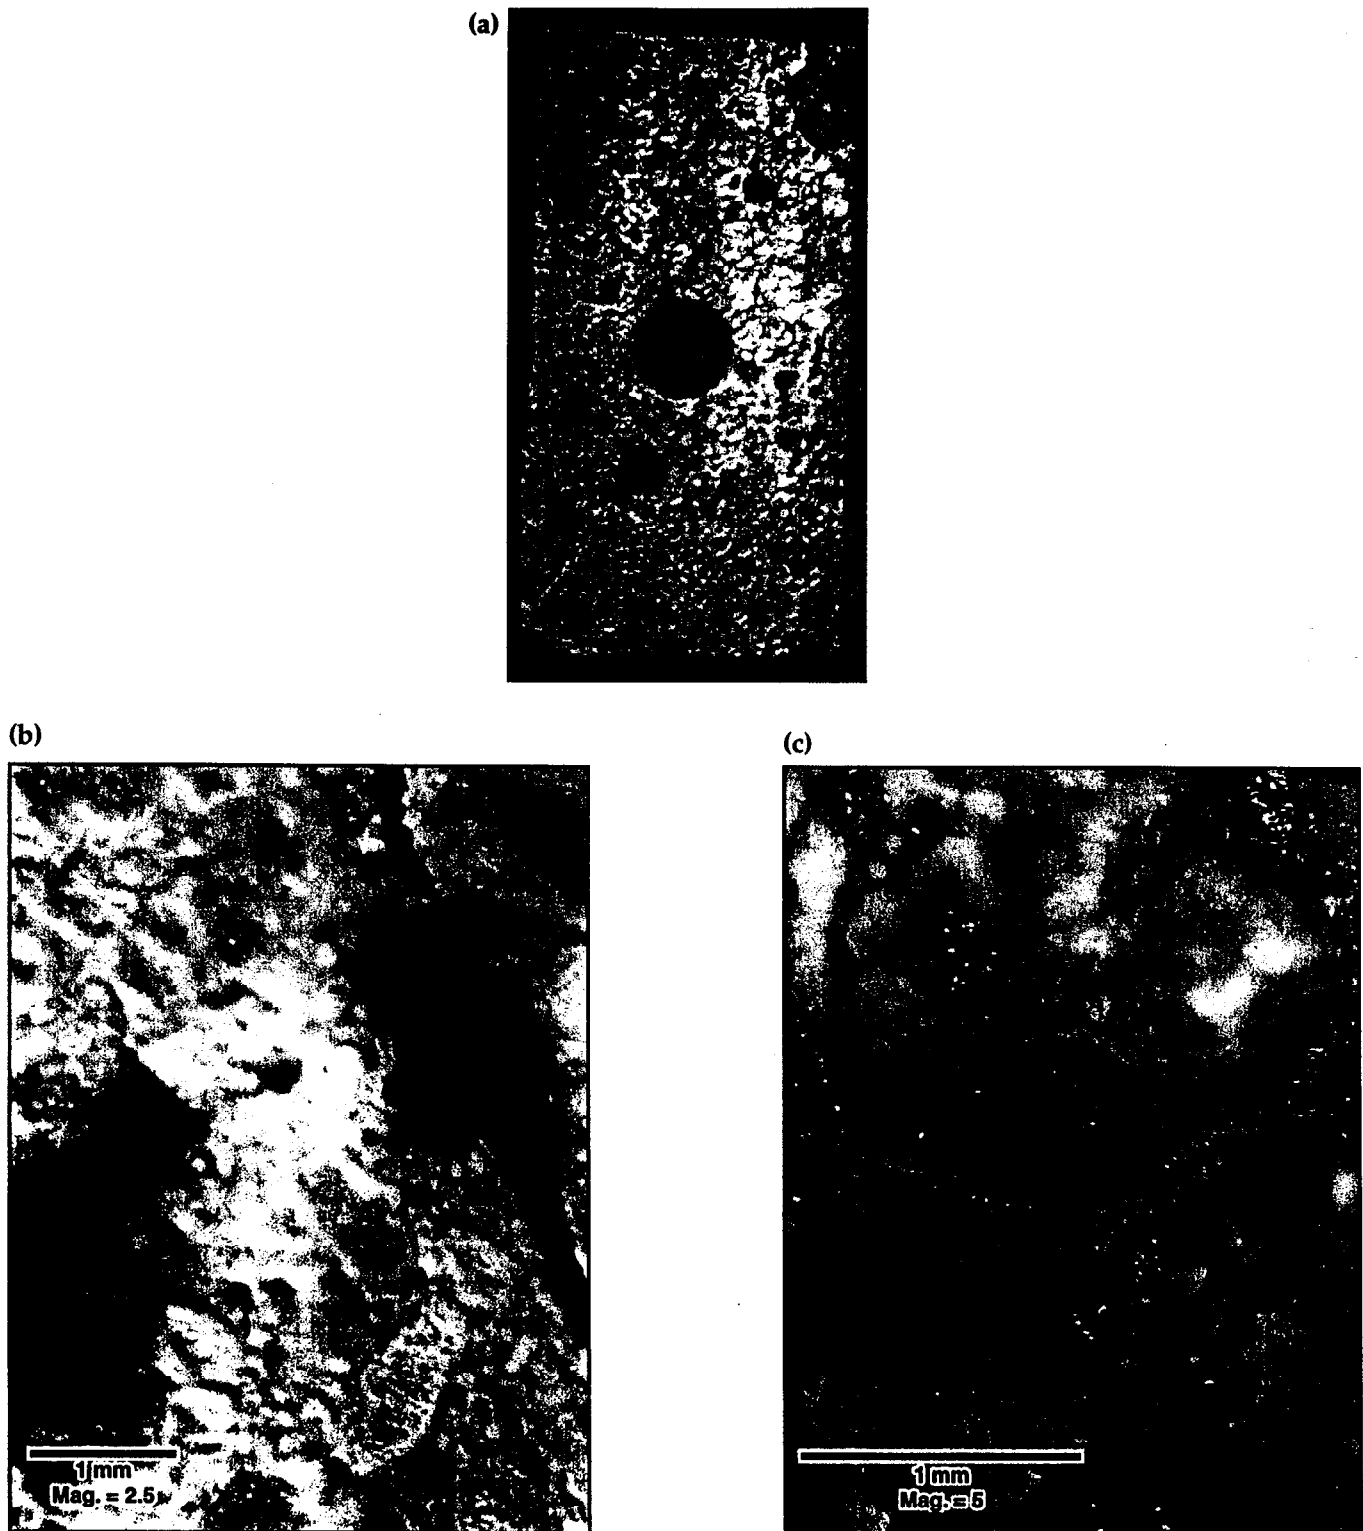
Figure 24. Photographs of sample SH-4. (a) The sample contains numerous grains with white rims. Note the crack in the corner of the sample. (b) A grain with a rusty appearance occurs in the crack near the corner of the sample. (c) Higher-magnification view of the white rims around many of the grains in the sample.

**Shotcrete. Vapor treatment. Sample SH-4.** This sample (Figure 24) contains numerous grains with white rims. The photos show a crack in the corner of the sample containing a fiber that appears to have oxidized. Also shown are high-magnification views of the white rims around many of the grains in the sample.

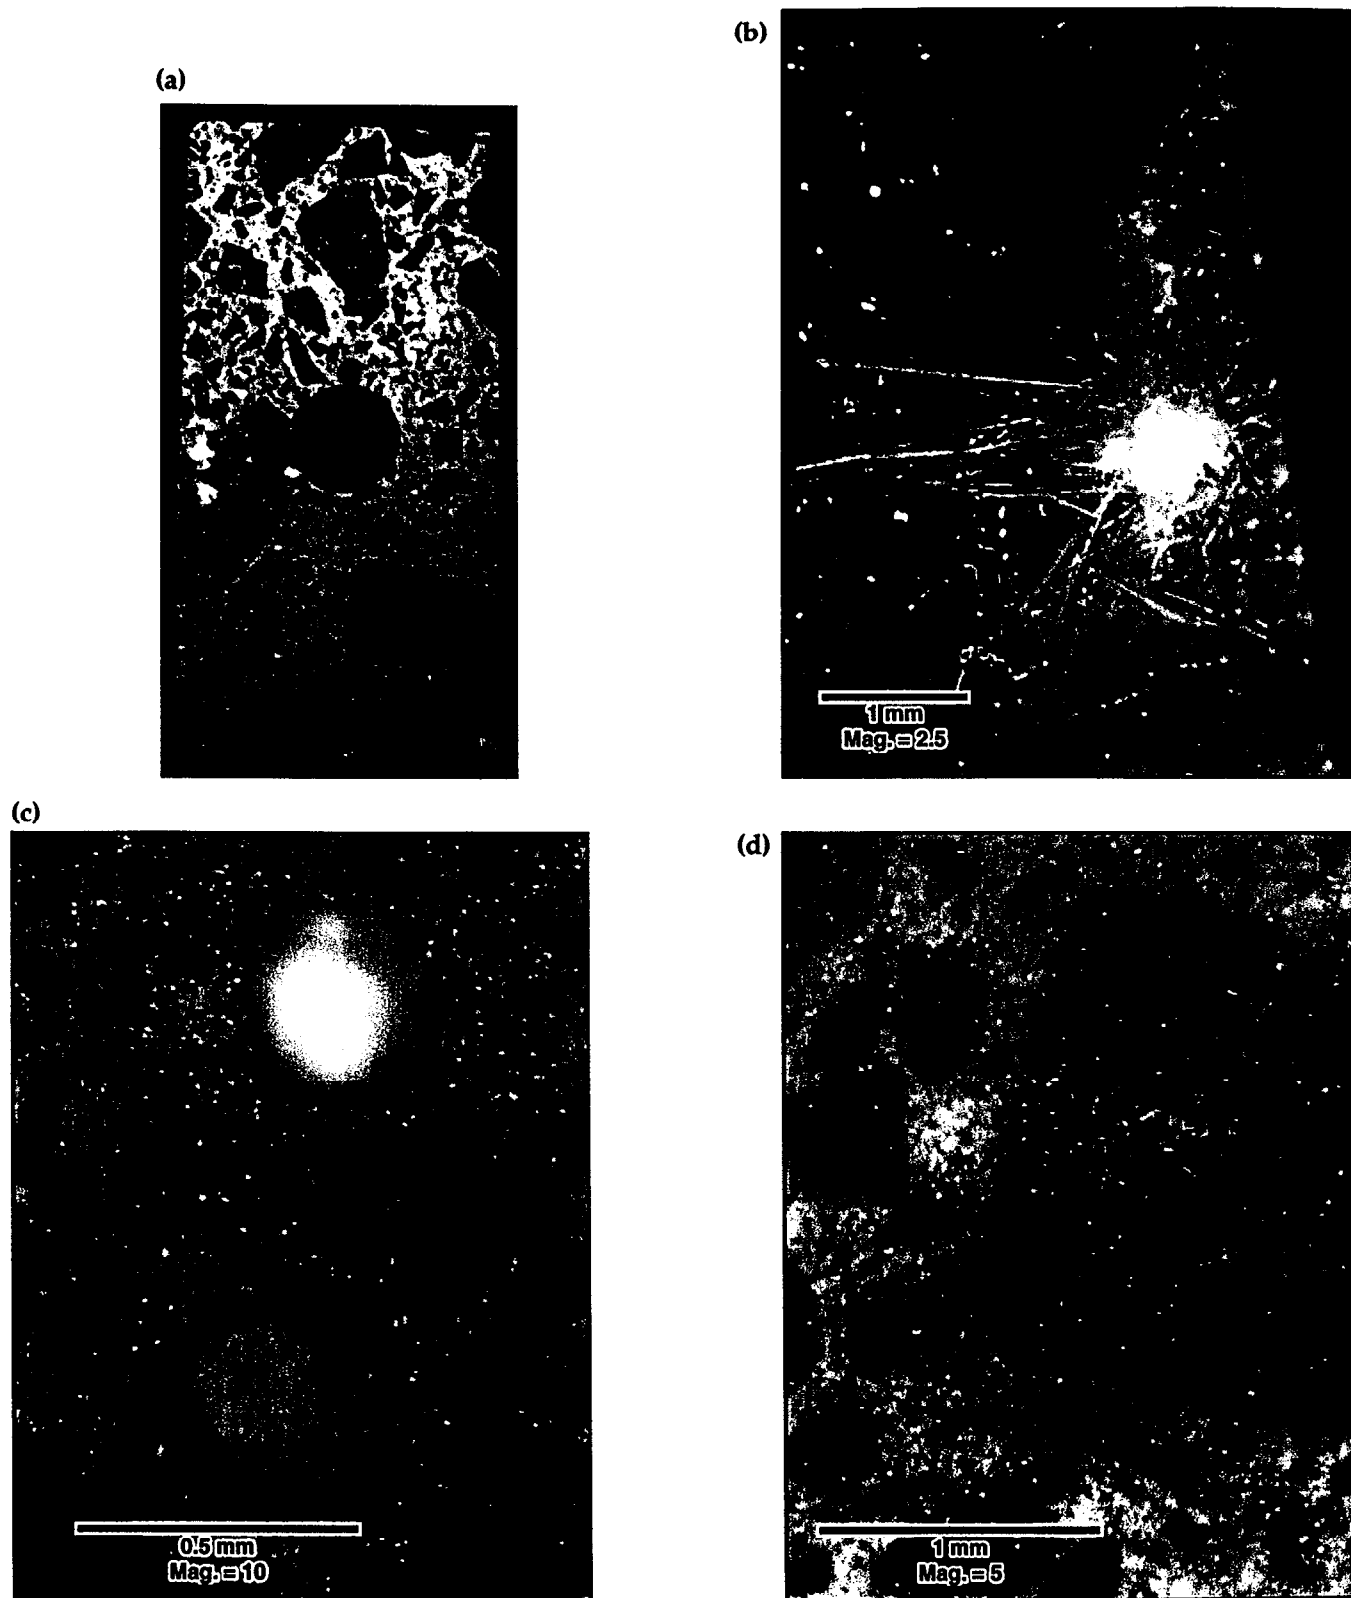
**Figure 19.** Photographs of sample INV-21. (a) Two clusters of white radiating crystals are visible near the edge of the sample. (b) The white radiating crystal clusters occur on the brownish aggregate grain. (c) Two pits in grout, filled with an out-of-focus, white substance. On focusing, the white substance has a sugary texture. There were several such pits on this sample. The small aggregate grains in this photo do not appear to have reaction rims. (d) Another white radiating crystal cluster on an aggregate grain.

**Invert. Aqueous treatment. Sample INV-21.** Notable features in this sample (Figure 19) include clusters of white radiating crystals that commonly occur on aggregate. At least five of these clusters were observed on the sample. Also photographed were two pits in grout, filled with a white phase that has a sugary texture. There were several such pits on this sample. The small aggregate grains in this photo do not appear to have reaction rims.

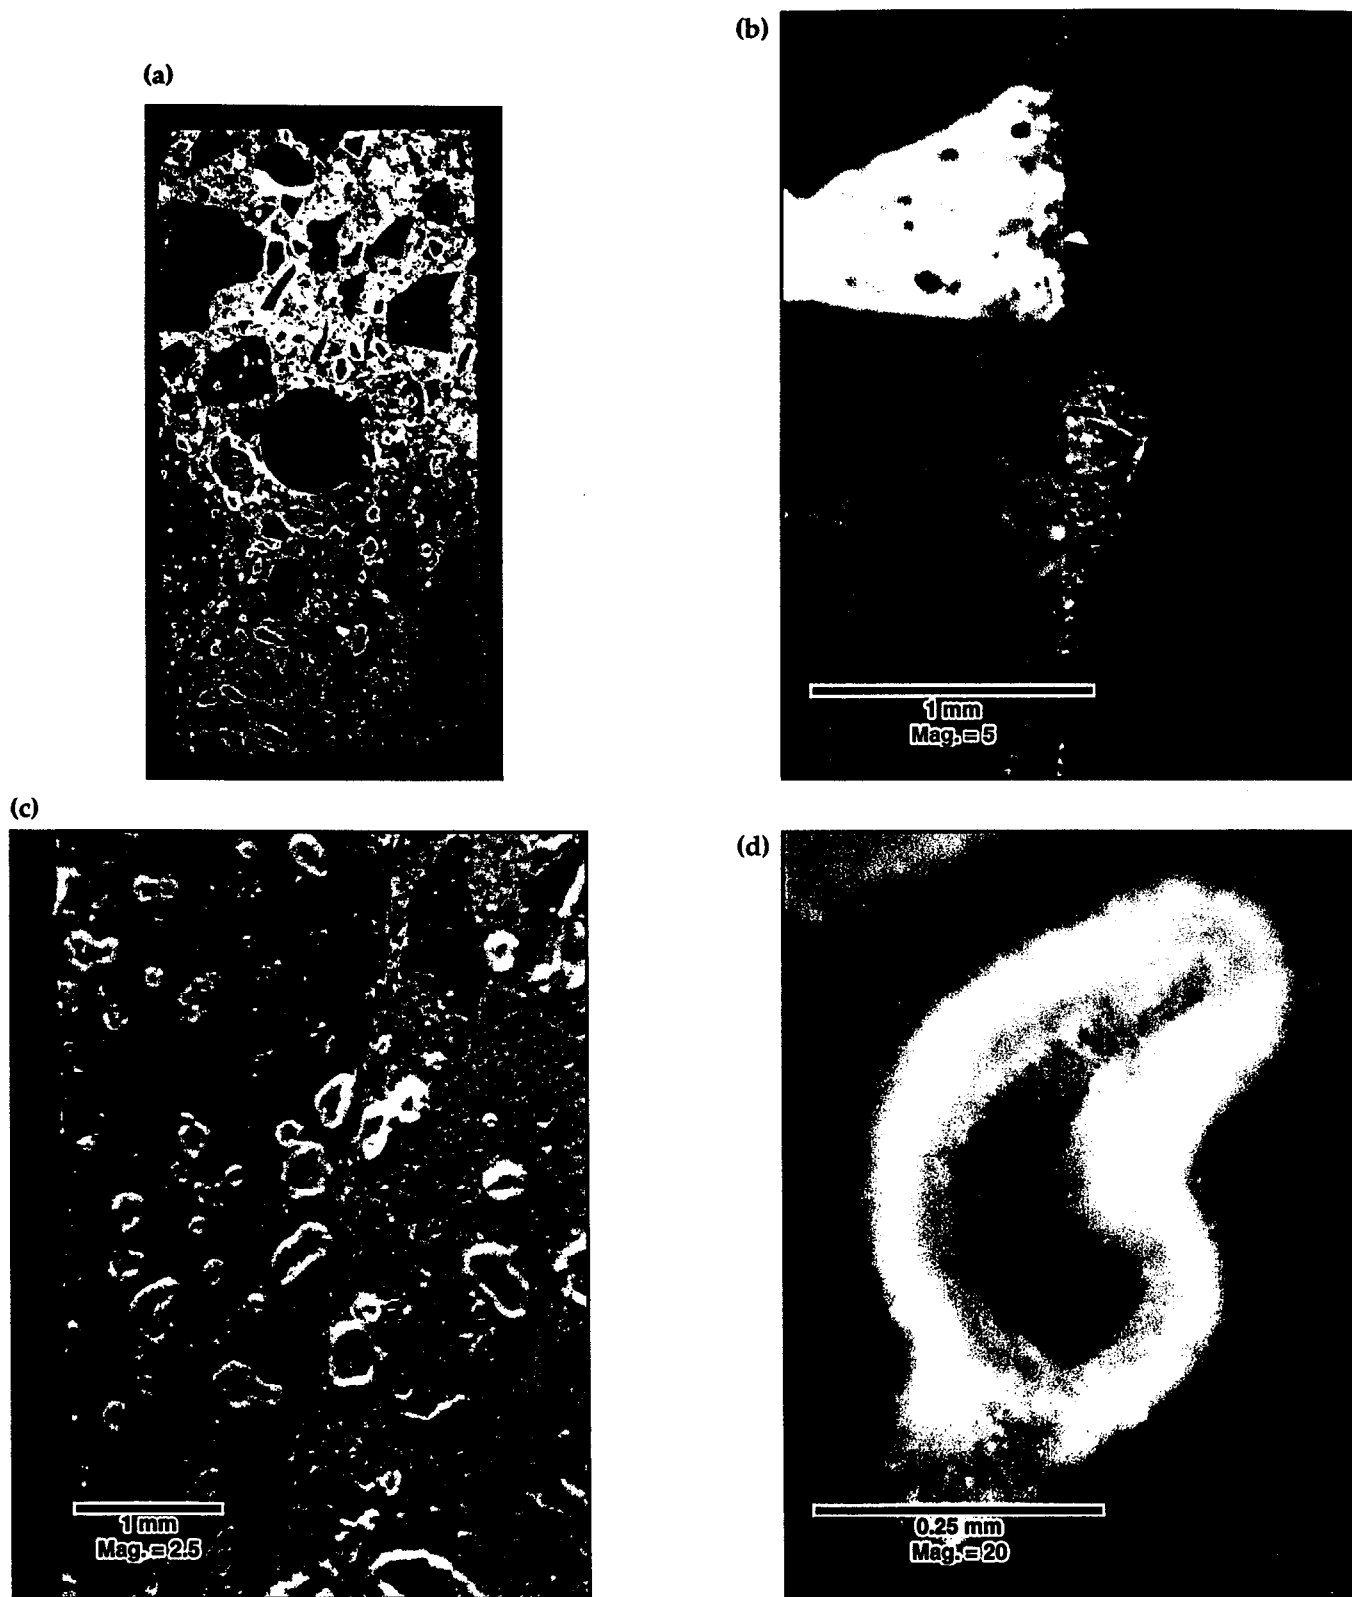
**Figure 20.** Photographs of sample INV-36. (a) White rims occur around the smaller aggregate grains and within the large grains. A large pit is visible. (b) A white fibrous mat of crystals attached to an aggregate grain on the edge of the sample. (c) White rims around smaller aggregate grains, and within a large aggregate grain. (d) A closer look at a white rim within an aggregate grain.

**Invert. Vapor treatment. Sample INV-36.** In the black and white photo (Figure 20), white rims of secondary phase can be observed around the smaller aggregate grains and within the large grains. A large pit is visible. Color photos reveal a white fibrous mat of crystals attached to an aggregate grain on the edge of the sample, as well as white rims around smaller aggregate grains and within a large aggregate grain. Other features are aggregate grains with no white rims, white rims that appear to be in grout (note the fine, white spindles on the inside one of the white rims), and a fibrous mat of crystals near the central hole in the sample. The crystals also radiate into the hole, but they are out of focus in the photo.

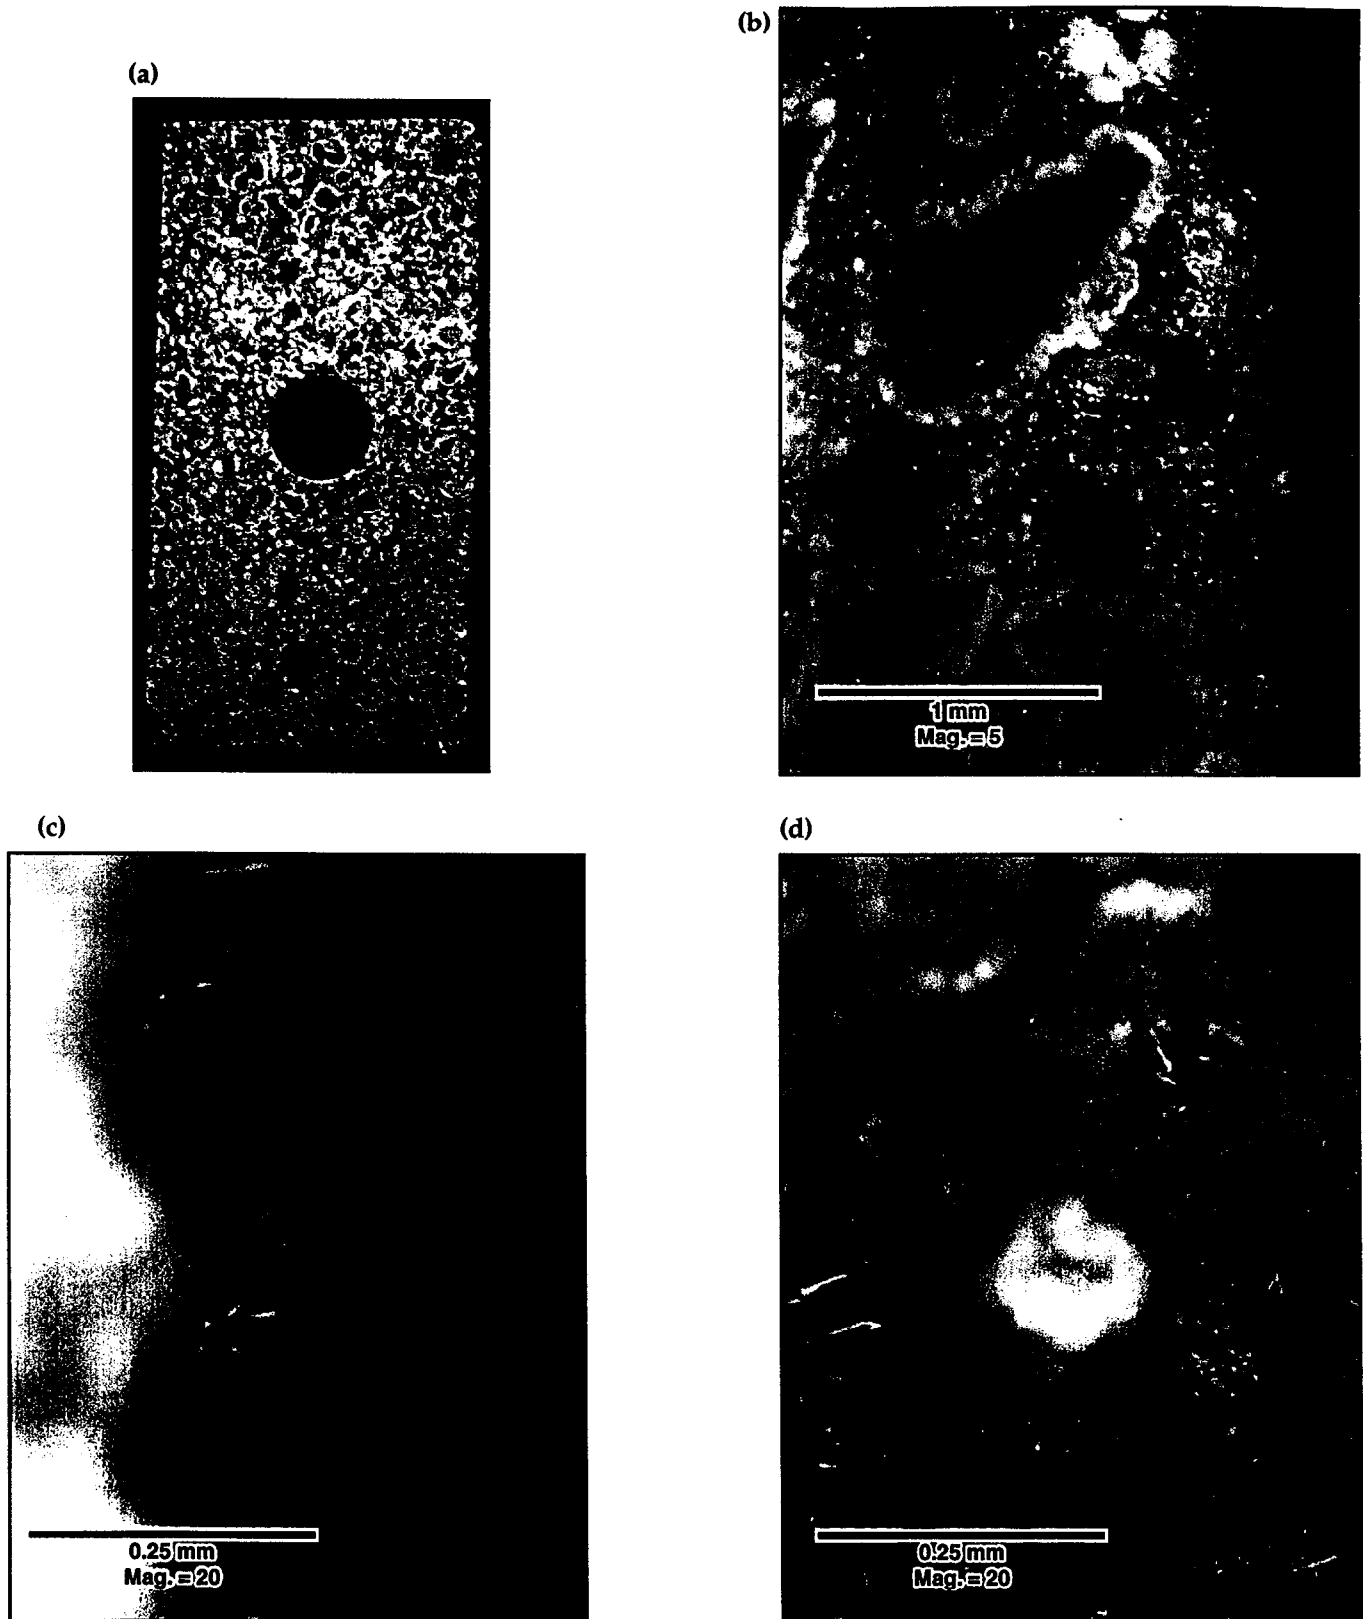
Figure 21. Photographs of sample SH-13. (a) Eighty to ninety percent of all the grains have visible white rims. (b) Representative view of sample. The grout generally sparkles in this sample. (c) Tiny white crystals radiate from the edge of the sample. (d) Needle-shaped crystals radiating from a mound of other crystals. The brown mineral is probably biotite and does not have a white rim.

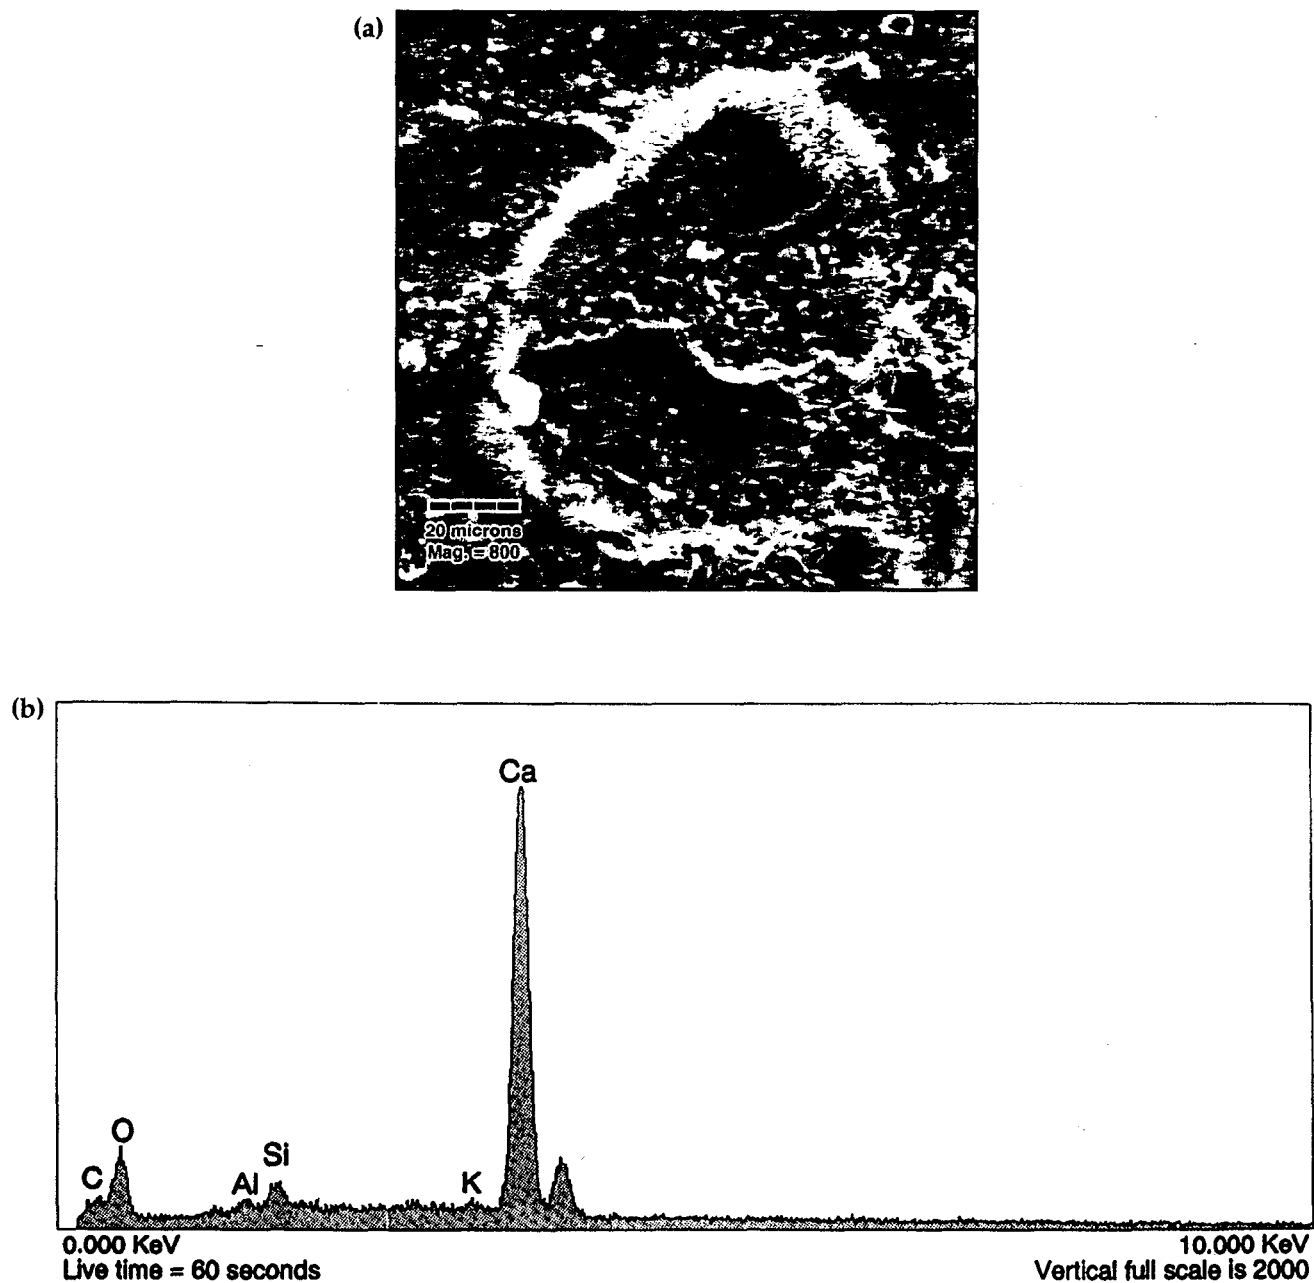
Figure 25. INV-37 (PV-13-37). (a) SEM photomicrograph of an aggregate grain, showing reaction phases around the rim. Reaction phases illustrated at higher magnification in Figures 26(a), 27(a), and 28(a). (b) EDS suggests that the grain is carbonate.

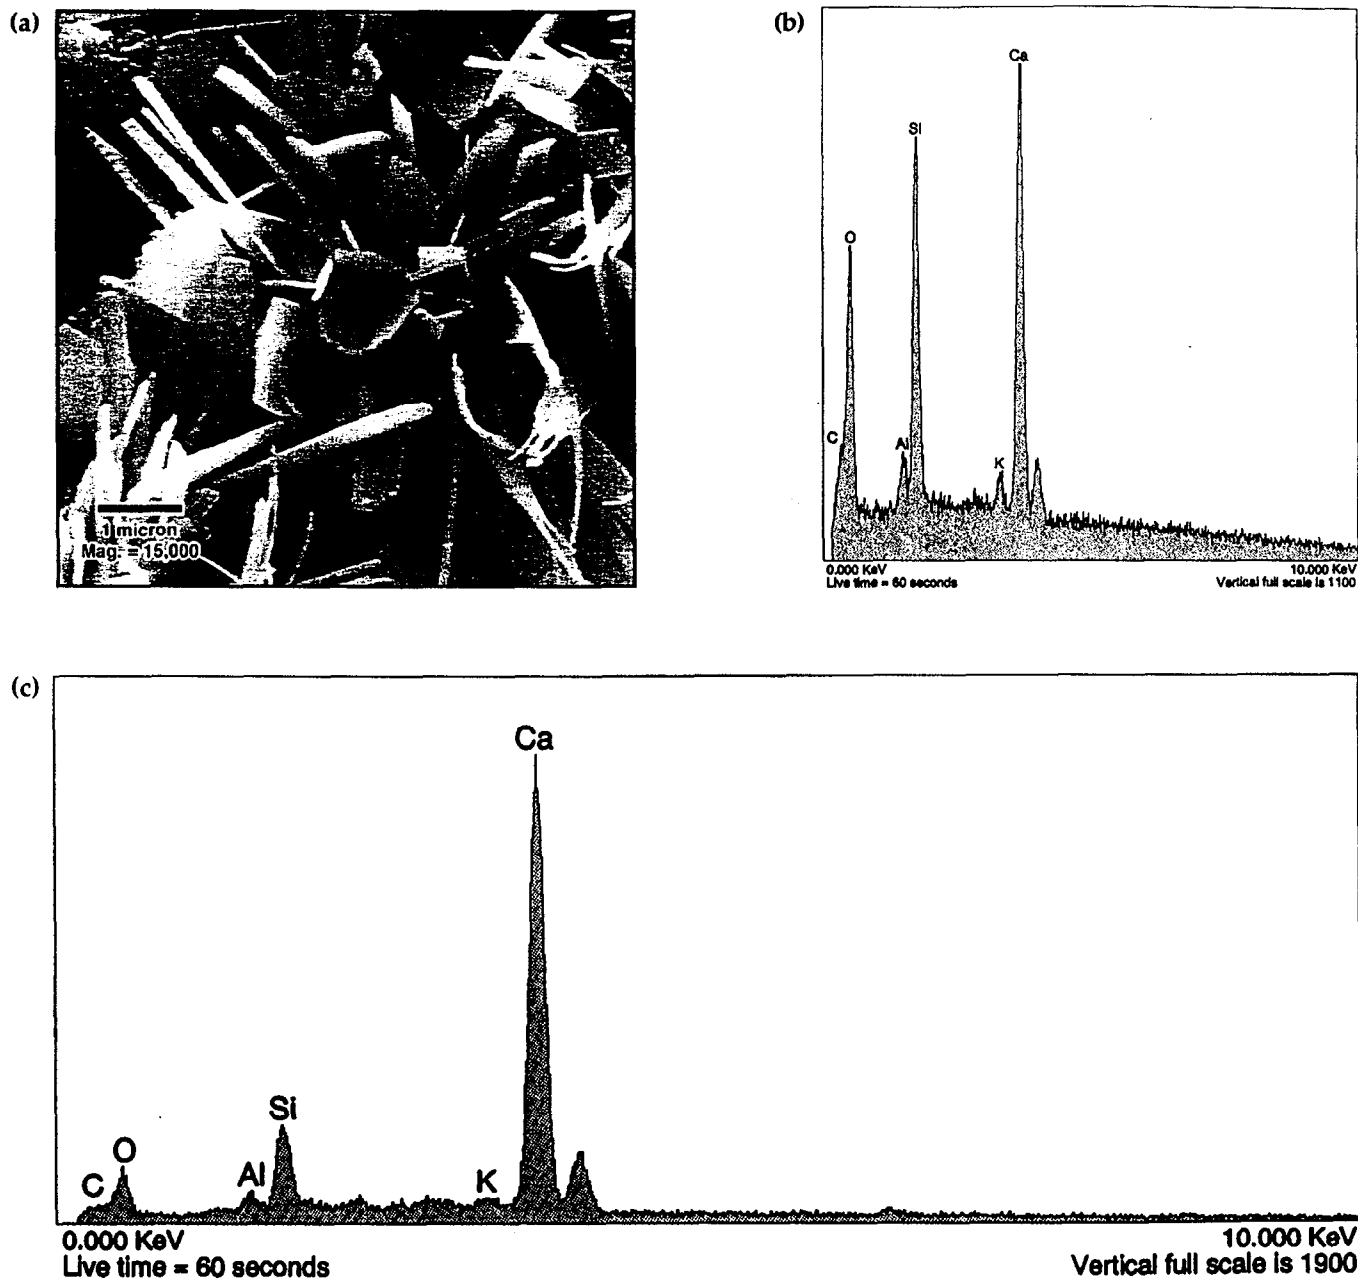
Figure 27. INV-37 (PV-13-37). (a) SEM photomicrograph of tabular crystals that occur on the upper-left side of the grain shown in Figure 25(a). (b) EDS indicates that the tabular crystals contain Ca, Si, and O in abundance, and minor amounts of Al, C, and K. (c) EDS from a smooth area in the grout just to the left of the crystals, indicates the presence of Ca, with lesser amounts of Si, O, Al, and K.

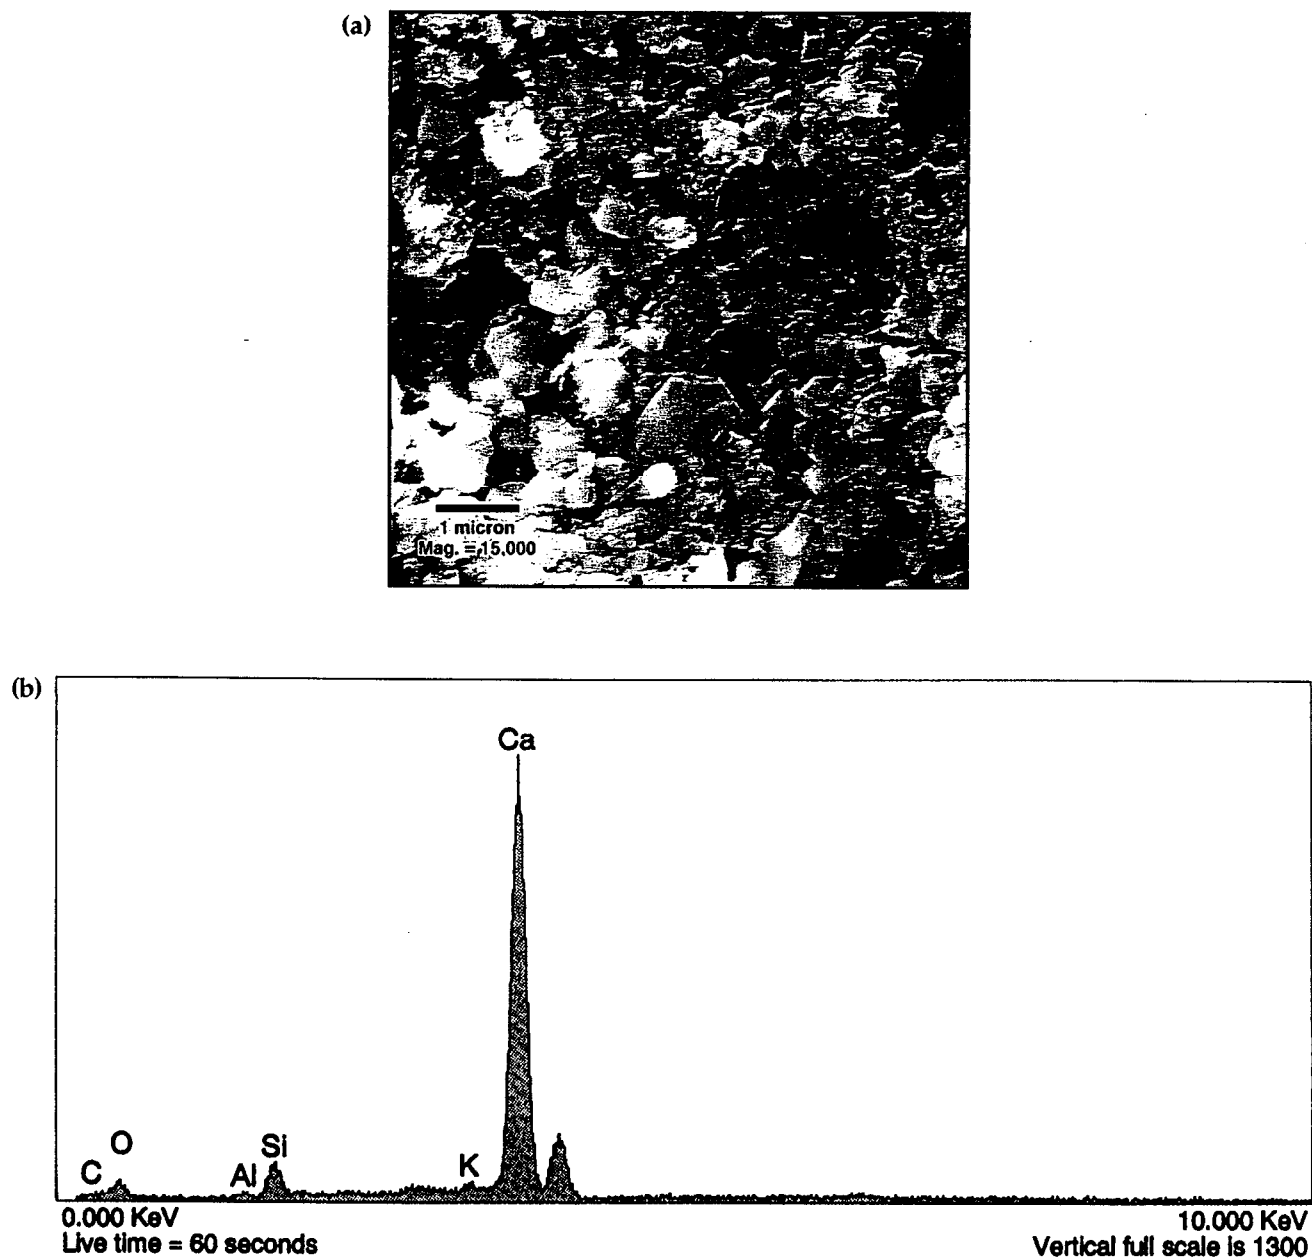
**Figure 29.** INV-37 (PV-13-37). (a) SEM photomicrograph of granular crystals outside of the grain, in the grout, to the left of the phase in Figure 27(a). (b) EDS indicates the presence of Ca with minor amounts of Si and O.

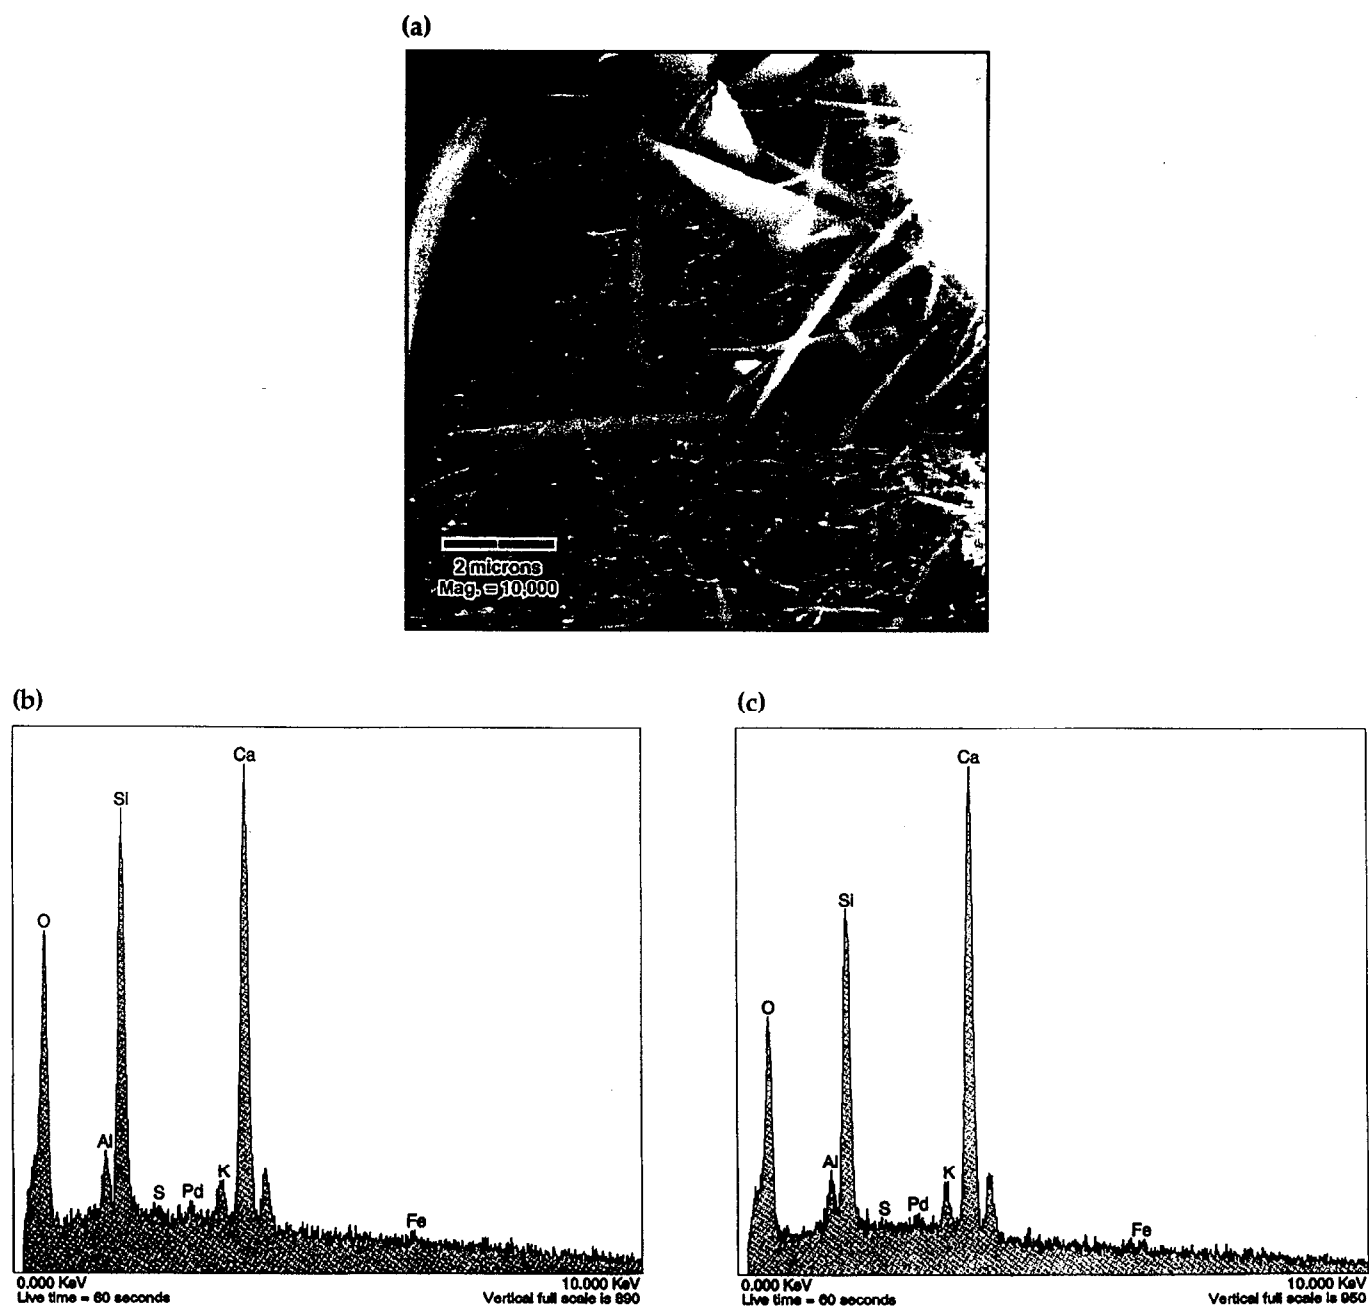
**Figure 31.** INV-38 (PV-13-38). (a) SEM photomicrograph of the grain-grout interface shown in Figure 30, at higher magnification. Two reaction phases are evident, a fine fibrous phase, and a tabular phase. (b) EDS of the fine fibrous phase indicates the presence of Ca, Si, O, Al, and K. (c) EDS of the tabular phase suggests the presence of Ca, Si, O, Al, and K. The Ca:Si:O ratios are slightly different between the two phases.

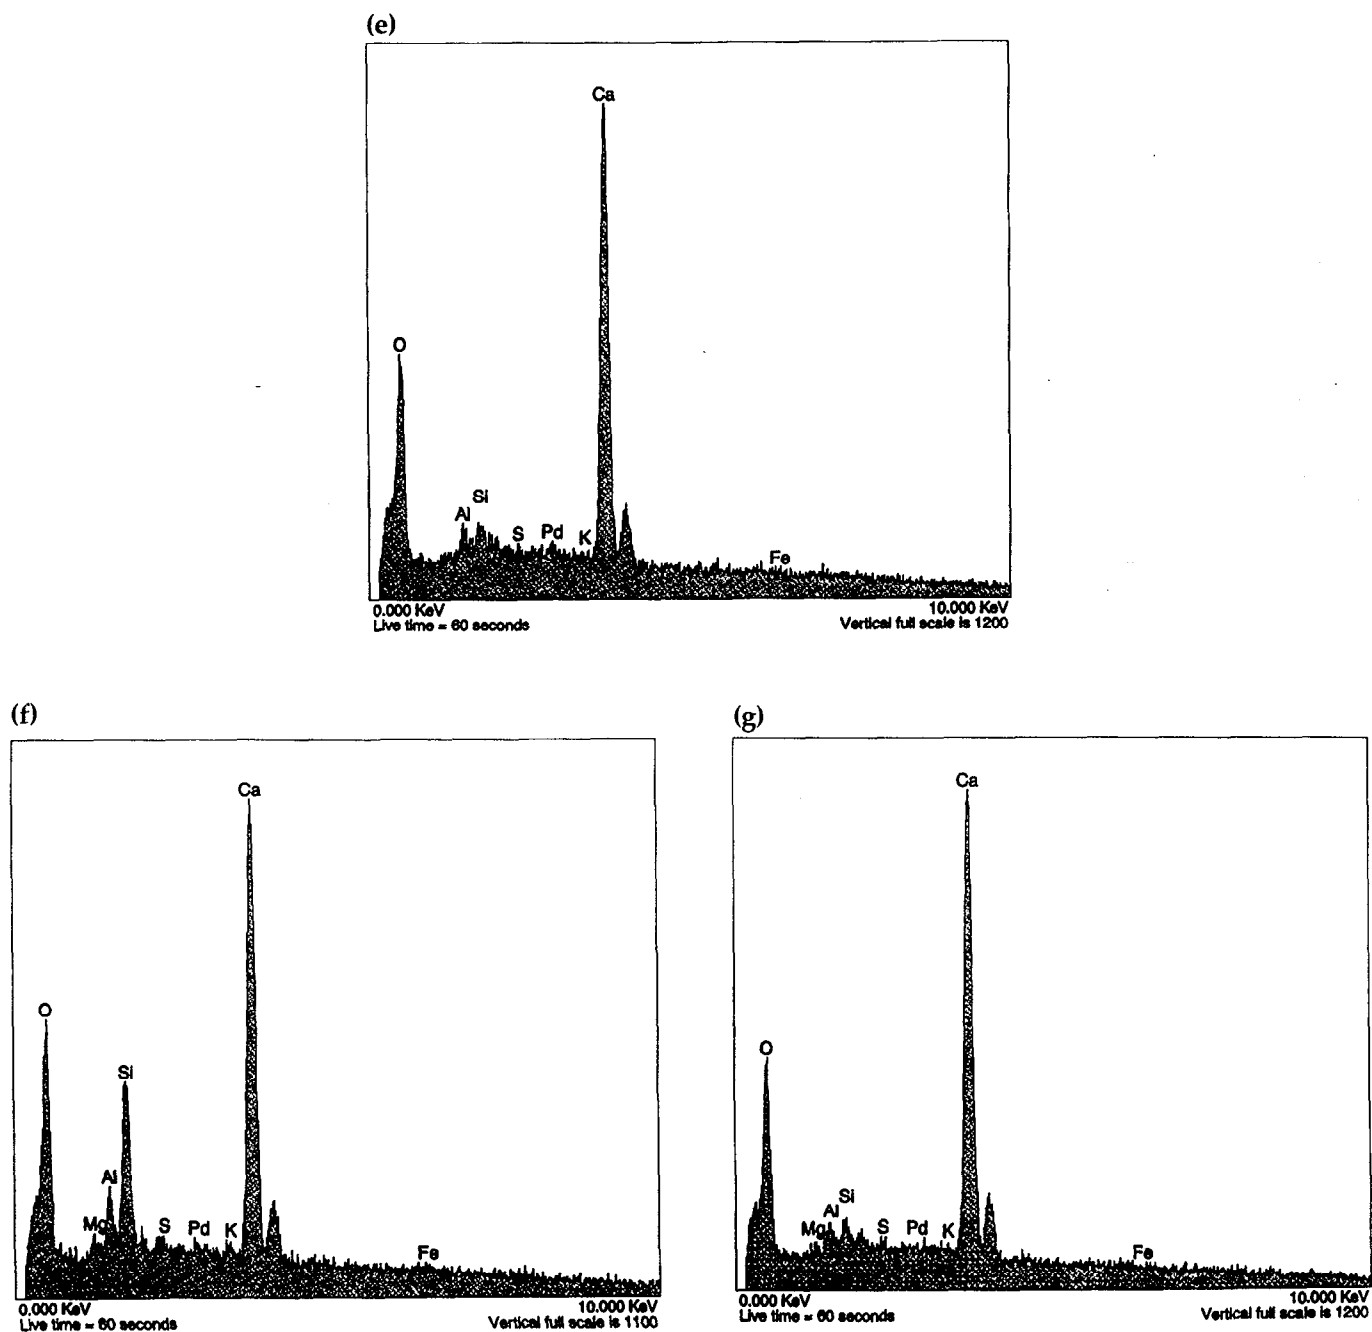
Figure 34 (continued). INV-38 (PV-13-38). (e) EDS of the other side of the fibrous crystals indicates a carbonate composition with Ca, O, and C with possible minor amounts of Si and Al. (f) EDS of one side of the tabular crystals indicates the presence of Ca, O, and Si with minor amounts of Al, Mg, and possible S. (g) EDS of the other side of the tabular crystals indicates the presence of Ca, O, and C (probably carbonate), with possible minor amounts of Al and Si.

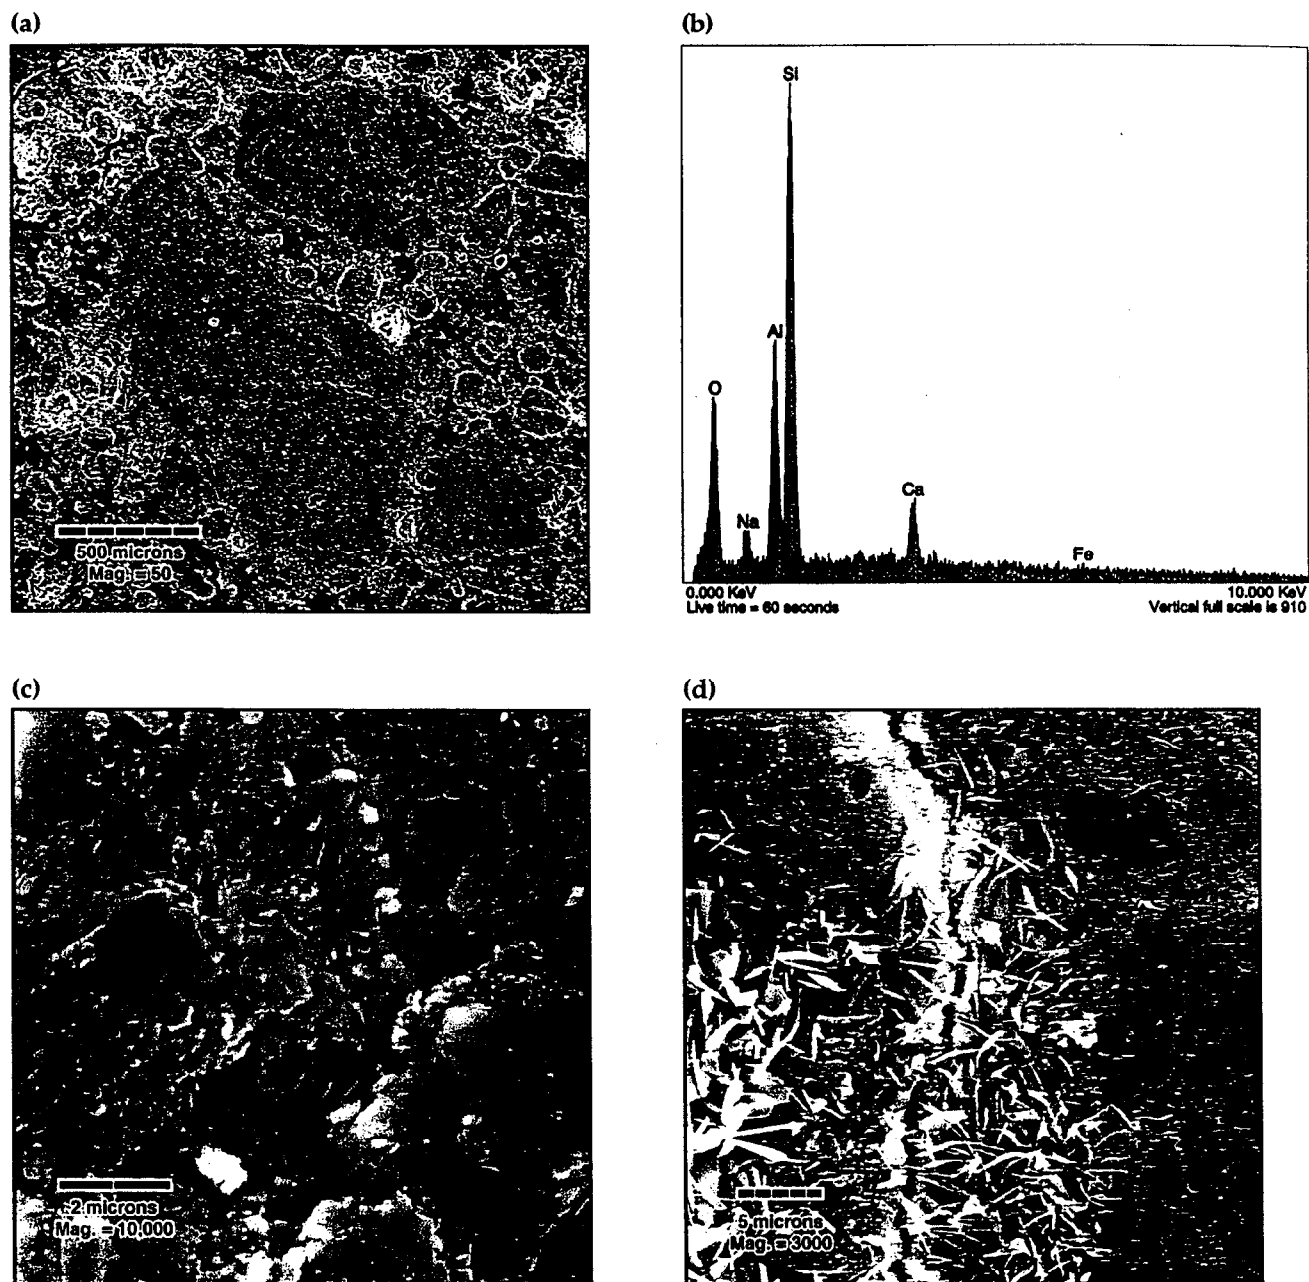
**Figure 37.** SH-9 (PV-13-9). (a) SEM photomicrograph of several aggregate grains. (b) EDS of largest grain indicates a plagioclase composition including Si, Al, O, Ca, and Na. (c) SEM photomicrograph of the center of the plagioclase grain. No alteration or reaction phases are evident. (d) SEM photomicrograph of a crack along the edge of the plagioclase grain. Note the presence of one or two different tabular reaction phases.

**Shotcrete.** The surface alteration on sample SH-9 (PV-13-9) is similar to that in the other dry treated samples. Several Ca-Si phases occur as alteration rims on grain boundaries, and several occur on grout. This sample also has a steel fiber that shows no reaction phases or alteration (Figure 35) and a carbonate phase that occurs in and around the drilled-out hole in the center of the sample (Figure 36). Feldspar grains were found both with reaction phases (Figure 37) and without (Figure 38 and Figure 39).
